**REPORT TITLE:** HEYWOOD PARK TREE RISK MANAGEMENT  
**ITEM NUMBER:** 3  
**DATE OF MEETING:** 24 NOVEMBER 2014  
**AUTHOR:** TREVOR STEIN  
**JOB TITLE:** SUSTAINABLE LANDSCAPE SPECIALIST  
**RESPONSIBLE OFFICER:** JOHN DEVINE  
**JOB TITLE:** GENERAL MANAGER ASSETS & INFRASTRUCTURE  
**COMMUNITY GOAL:** 4.3 - Functional open-green space throughout the City of Unley.  
**REPRESENTOR/S:** Nil  
**ATTACHMENTS:**

# Heywood Park - Recommended Tree Removal Summary

## Heywood Park – Proposed Regulated & Significant Tree Removals

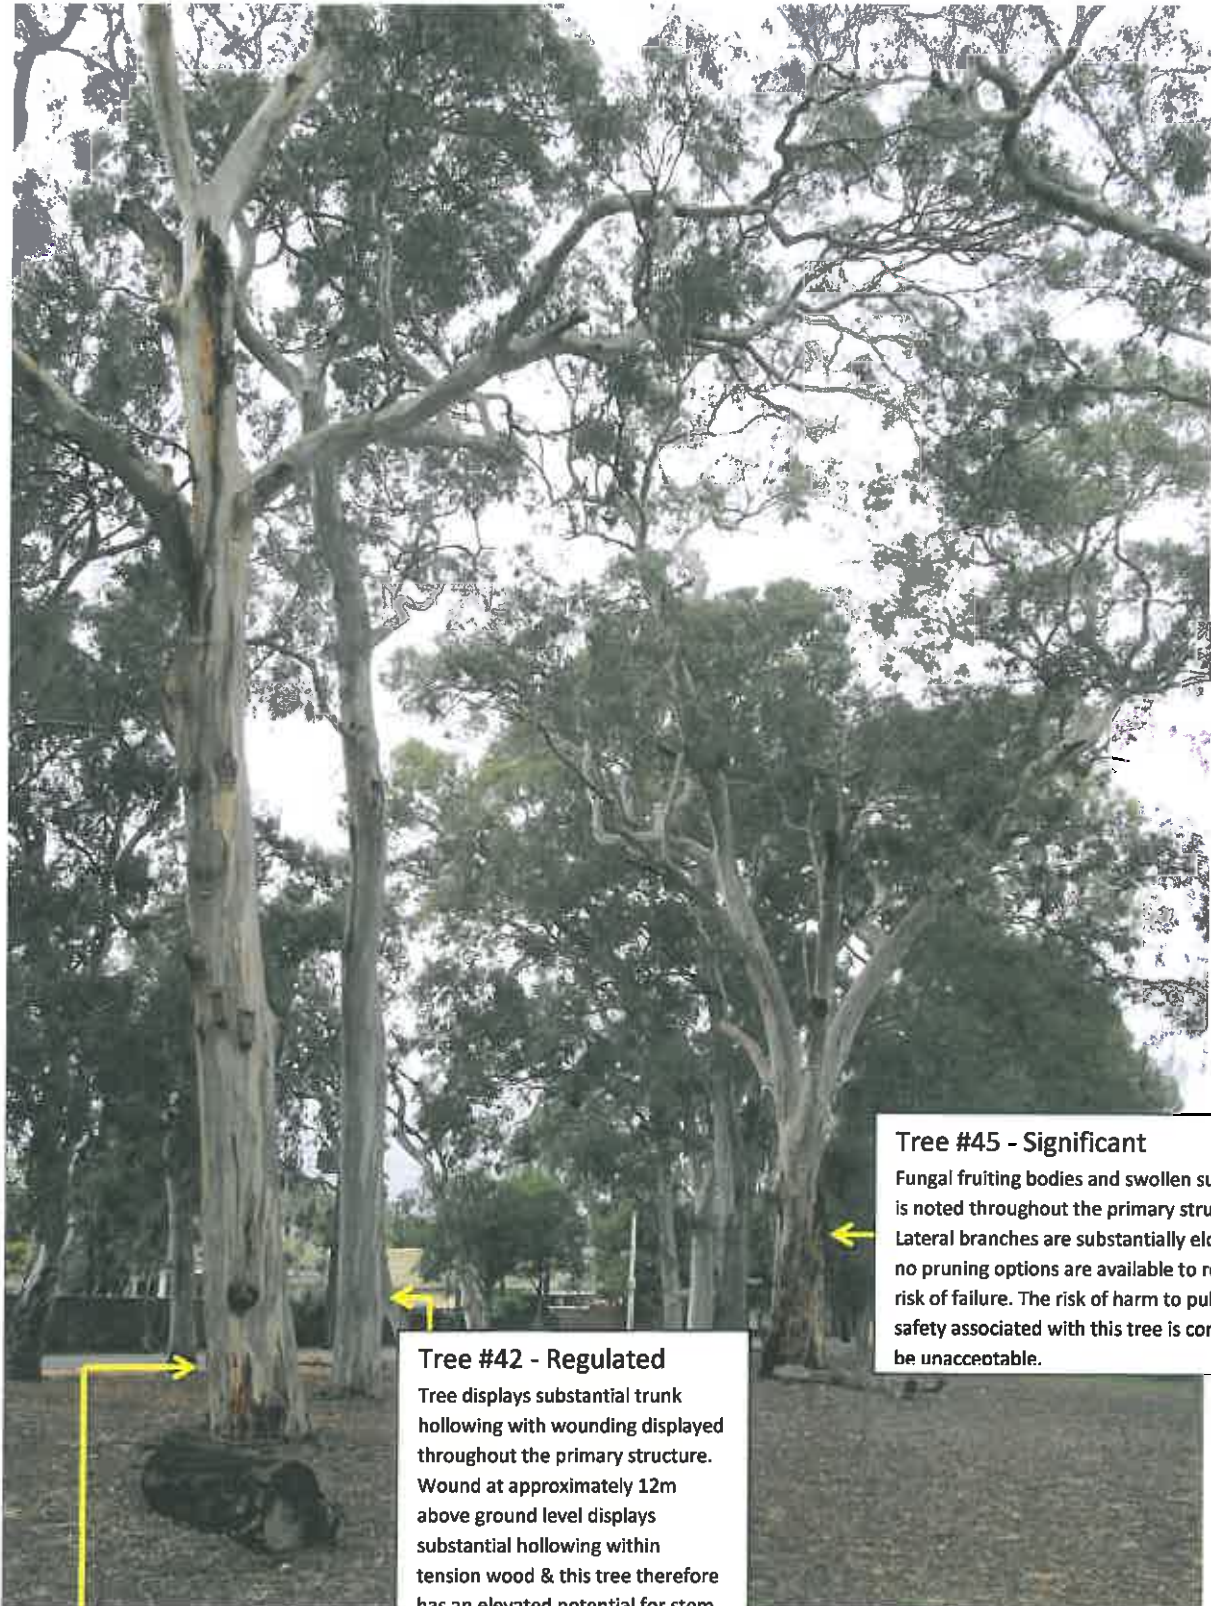
Initial concerns identified that one of these trees (Tree # 45) if retained would require the relocation of play equipment nearby. A major limb from this tree was within the fall zone of the playground. Detailed diagnostic works identified the need for removal of the tree, thus eliminating any risk to playground users.

**Tree #45 - Significant**  
Fungal fruiting bodies and swollen support timber is noted throughout the primary structure. Lateral branches are substantially elongated and no pruning options are available to reduce the risk of failure. The risk of harm to public & private safety associated with this tree is considered to be unacceptable.

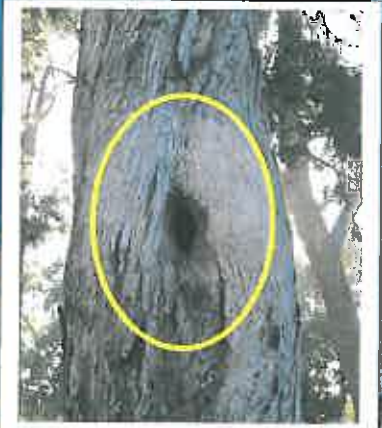
Trunk degradation and breach. Note the minor trunk swelling at the area of structural inadequacy.

**Tree #19 – Regulated**  
A trunk wound within the western primary structure has exposed substantial hollowing and further analysis using resistograph instrumentation demonstrates that the trunk has a t/R ratio of 0.17. This is not sufficient to maintain support for the structure and this tree has a high potential for failure as a result.

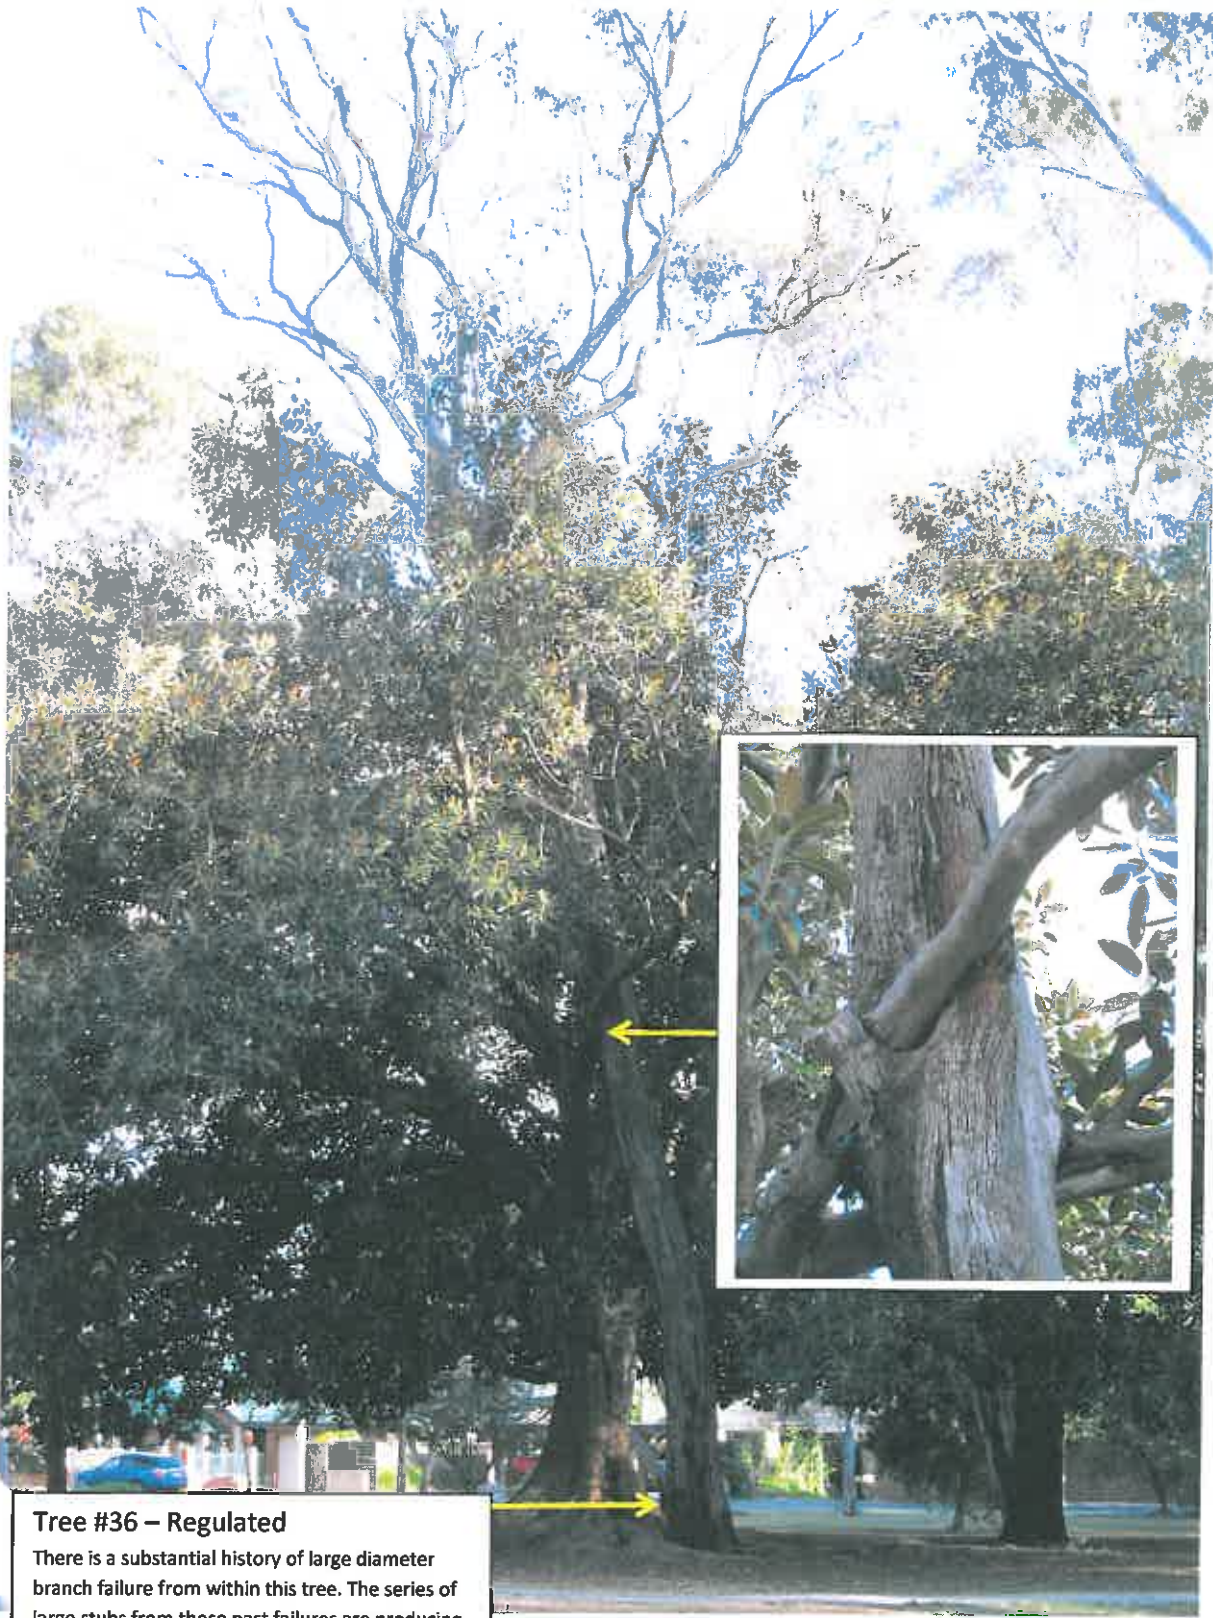
**Tree #36 – Regulated**  
There is a substantial history of large diameter branch failure from within this tree. The series of large stubs from these past failures are producing epicormic development. This tree is deformed due to the competition of the larger *Ficus macrophylla* (Moreton Bay Fig) adjacent to it.

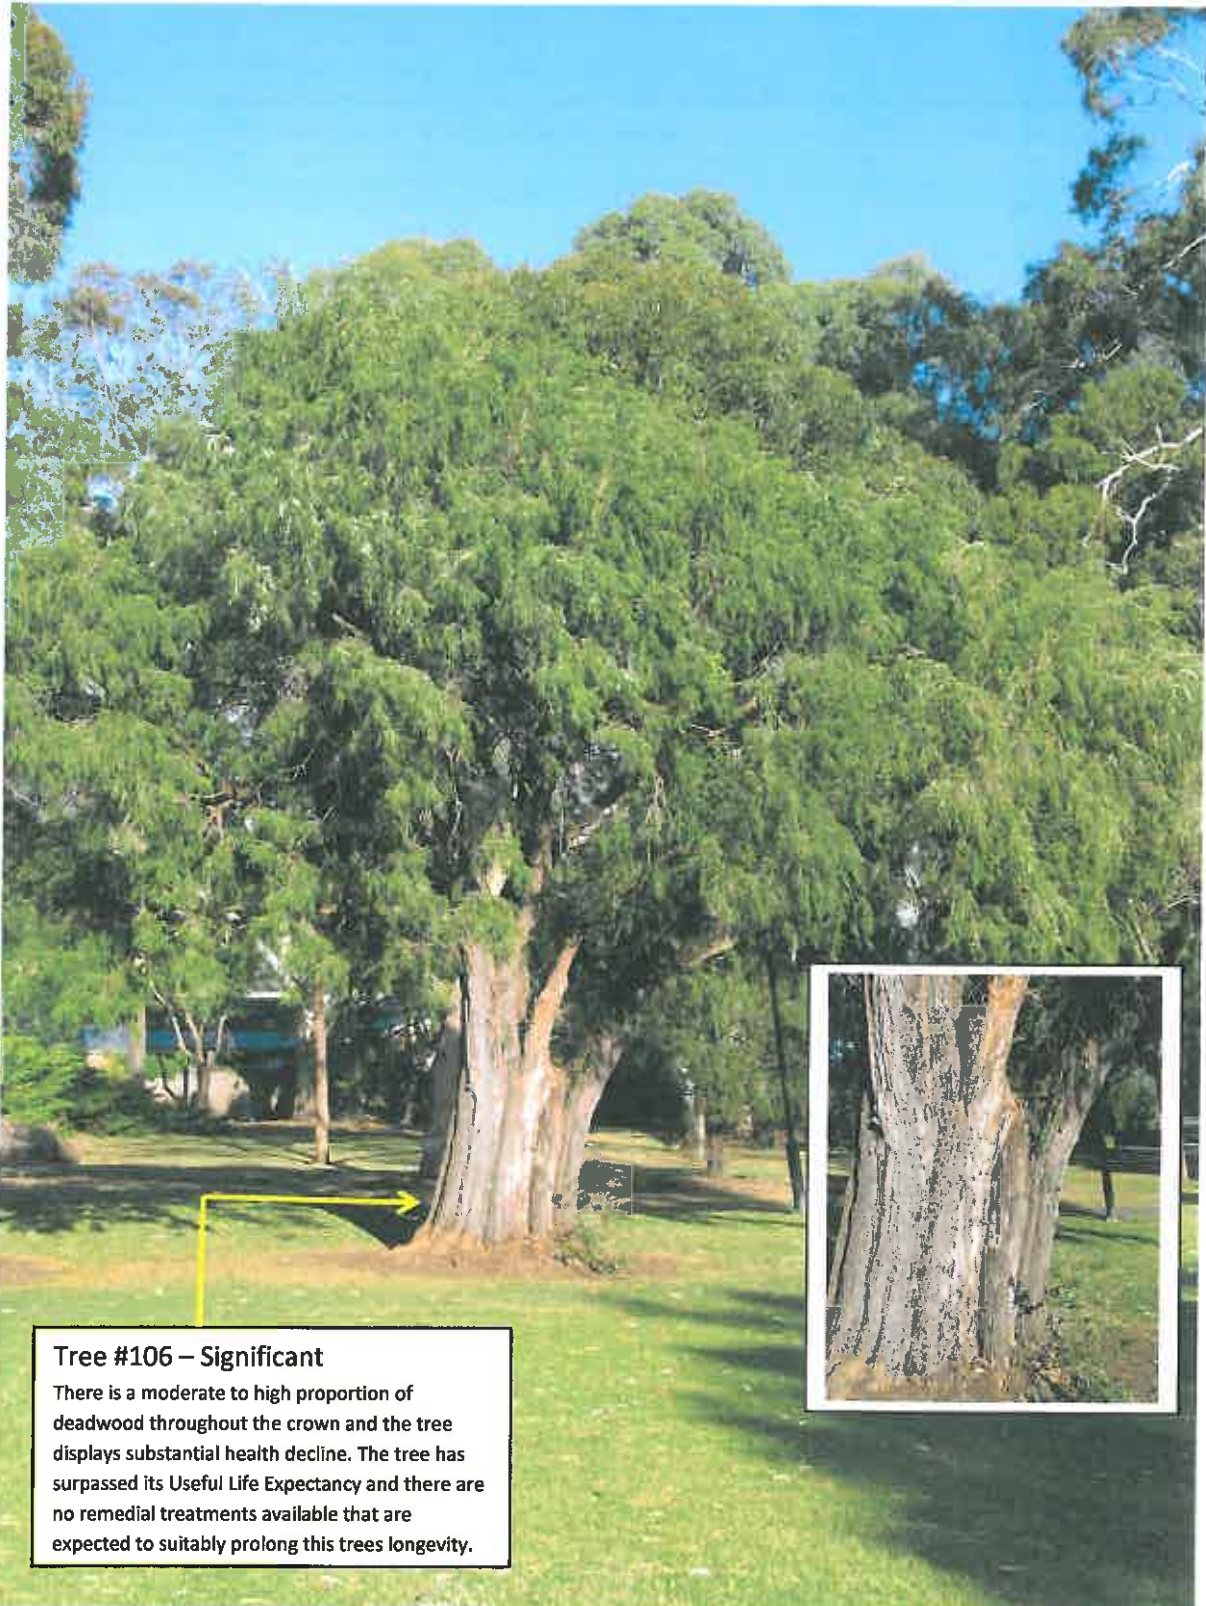
**Tree #106 – Significant**

There is a moderate to high proportion of deadwood throughout the crown and the tree displays substantial health decline. The tree has surpassed its Useful Life Expectancy and there are no remedial treatments available that are expected to suitably prolong this trees longevity.

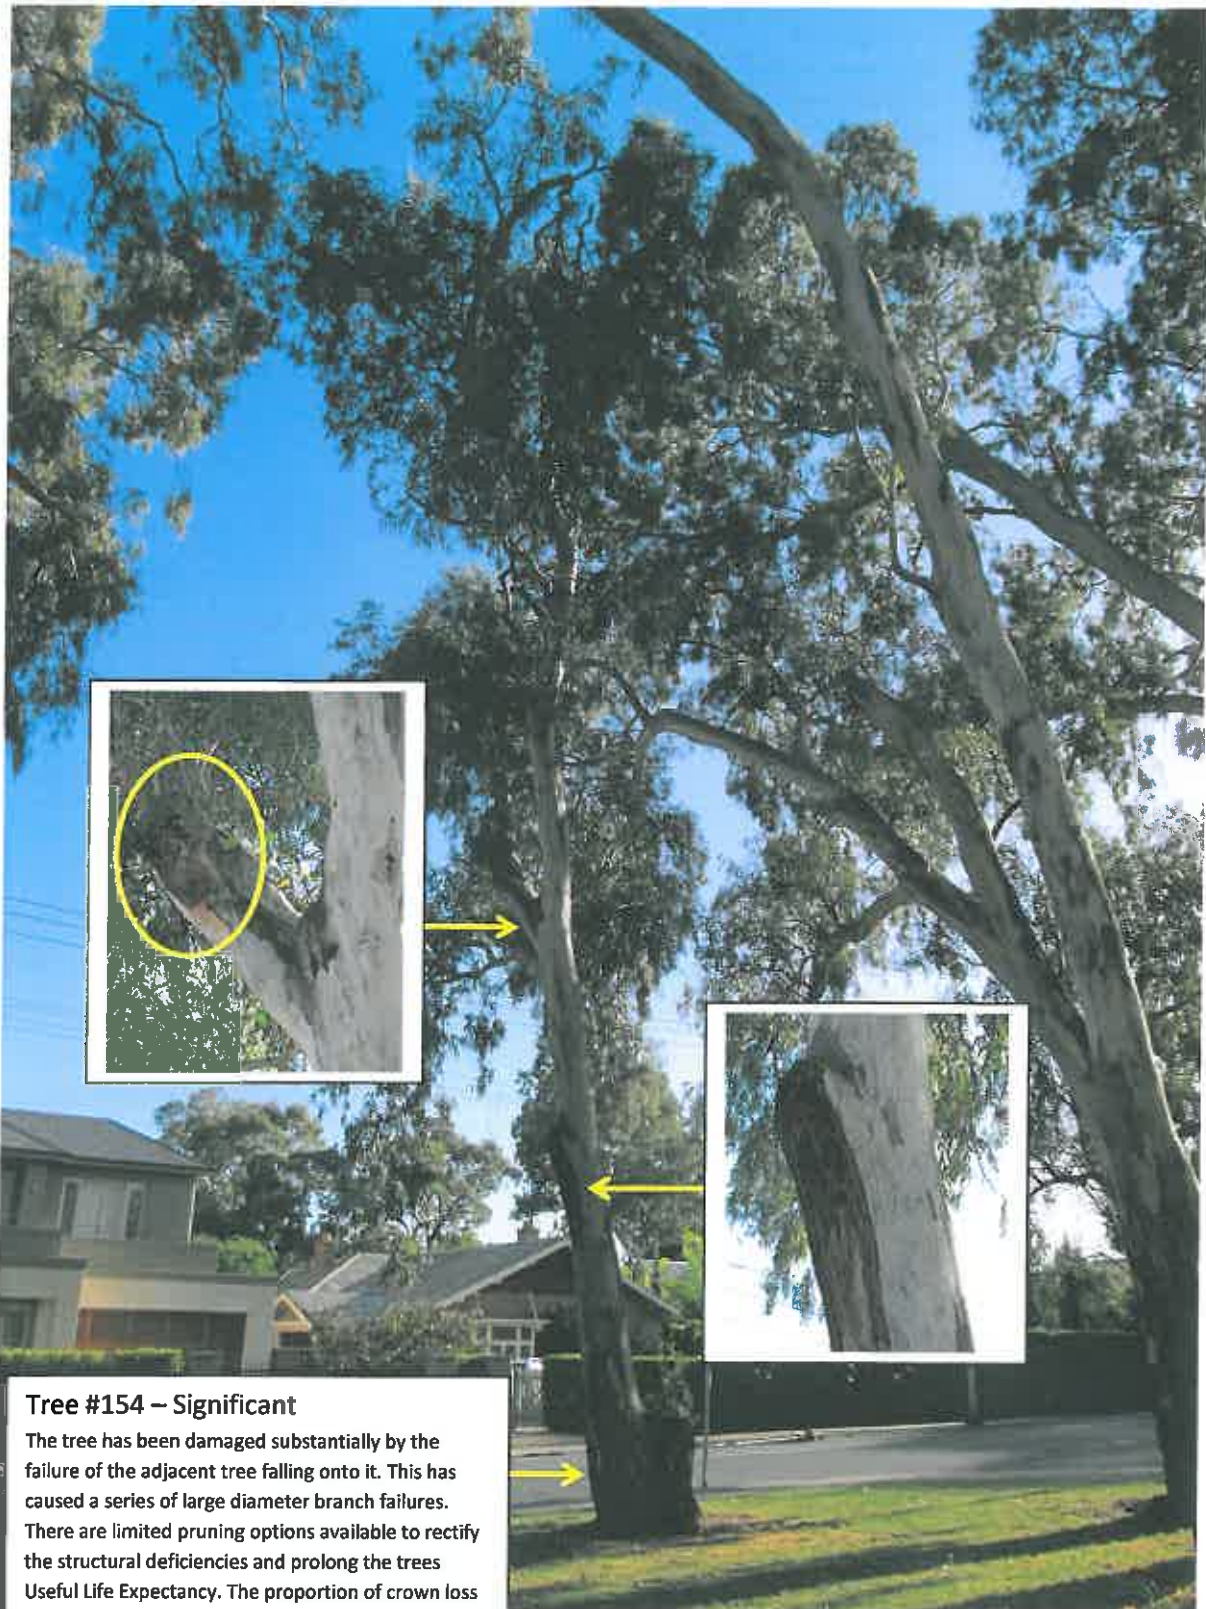
**Tree #154 – Significant**

The tree has been damaged substantially by the failure of the adjacent tree falling onto it. This has caused a series of large diameter branch failures. There are limited pruning options available to rectify the structural deficiencies and prolong the trees Useful Life Expectancy. The proportion of crown loss due to the branch failures will result in health decline and has resulted in an irregular crown form.

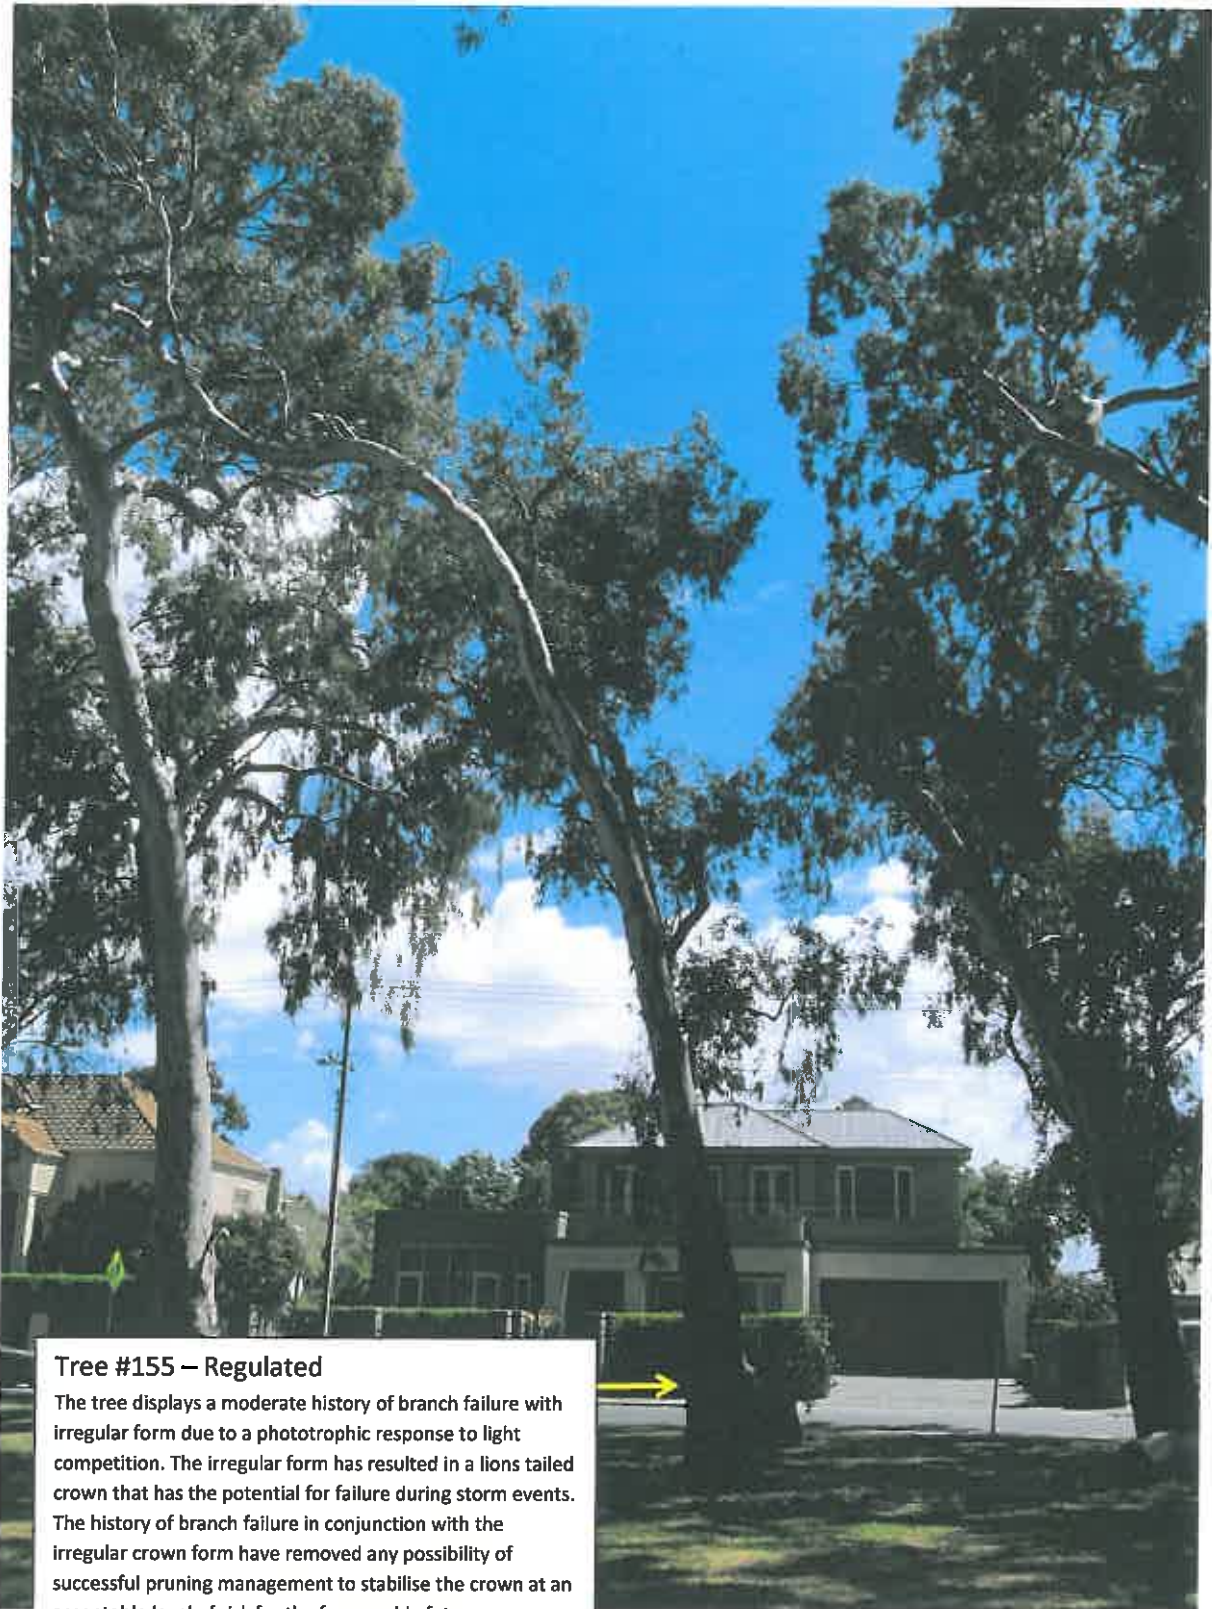
**Tree #155 – Regulated**

The tree displays a moderate history of branch failure with irregular form due to a phototropic response to light competition. The irregular form has resulted in a lions tailed crown that has the potential for failure during storm events. The history of branch failure in conjunction with the irregular crown form have removed any possibility of successful pruning management to stabilise the crown at an acceptable level of risk for the foreseeable future.

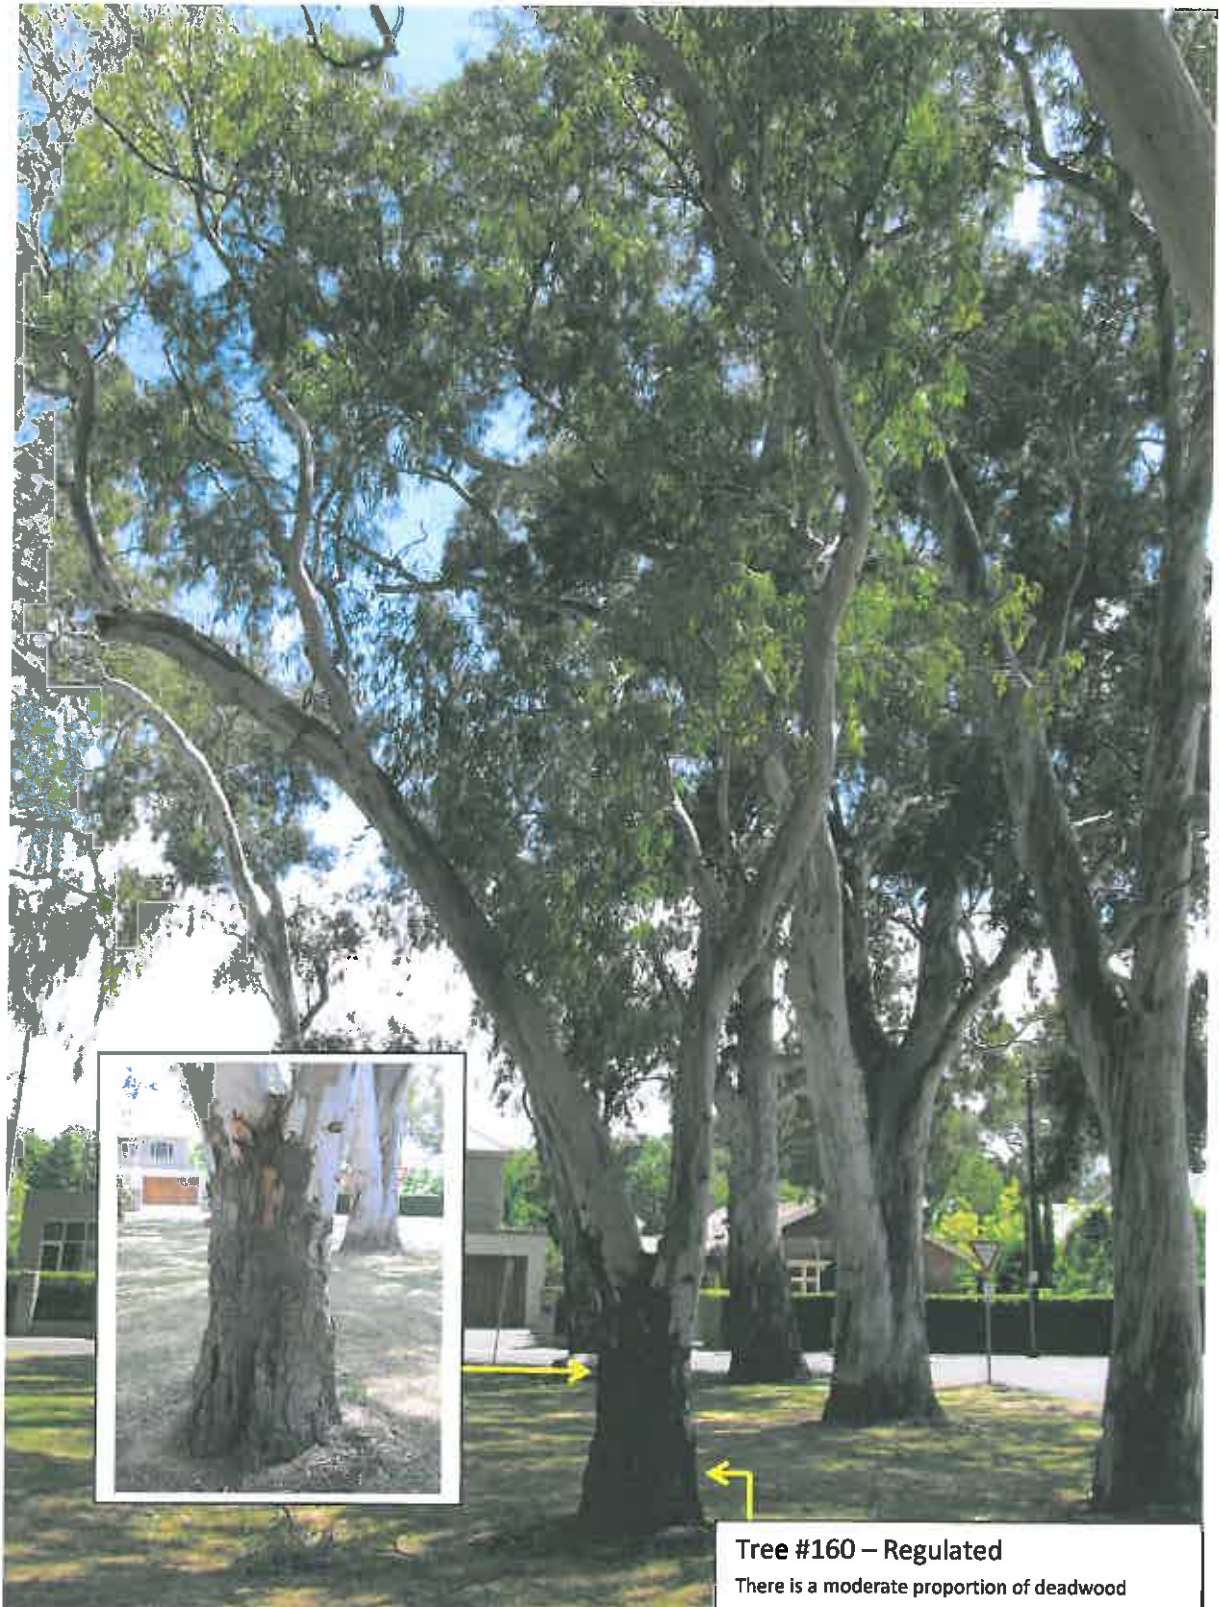
**Tree #160 – Regulated**

There is a moderate proportion of deadwood throughout the crown as well as notable health decline. The tree displays significant health decline and remedial treatments to prolong its life expectancy are considered futile given the current growing environment.
