Black Forest LATM

Final Report

City of Unley

Ref No. 20121294FR1F

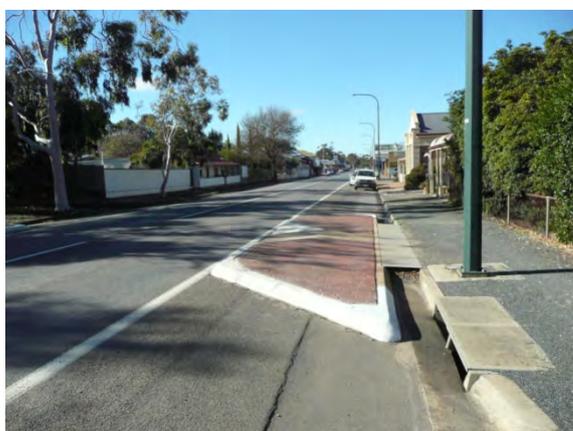
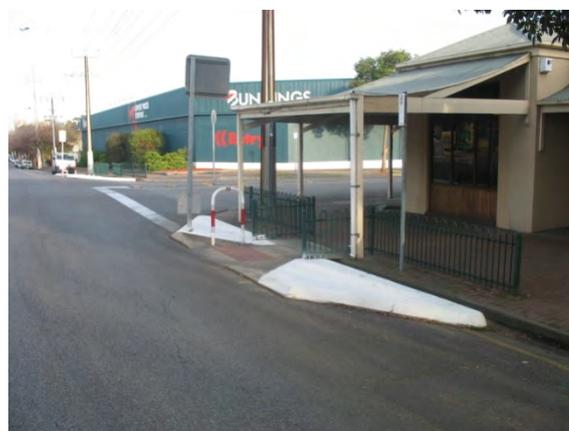
Example Kerb Build Outs

Refine the proposed plan (as shown in Appendix E Concept Plan) to ensure minimal impact on parking loss, and progress installation of these treatments through consultation with immediately affected residents

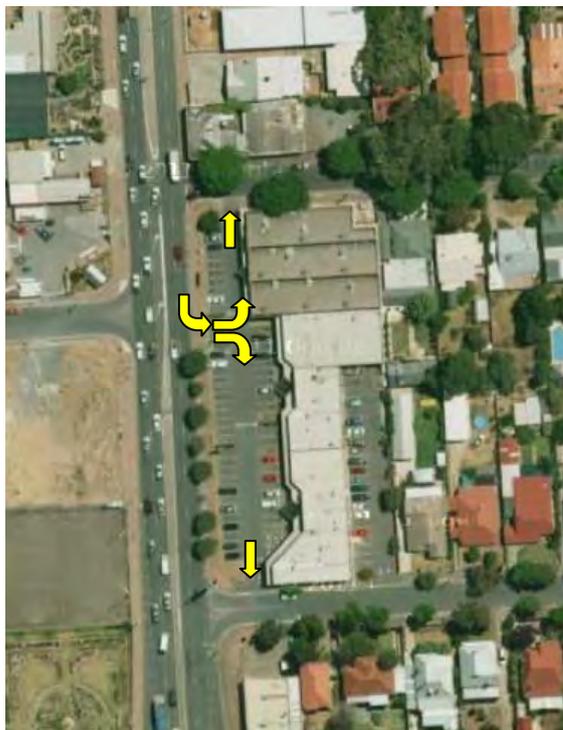
Option A

Ideally, alternative access arrangements should be negotiated with the owners with consideration given to (for example) one way in/out operation of the car park, or access only from South Road and egress via Byron Road or Cowper Road. However, restricting access directly from South Road only would desirably need an improved driveway access to 'ease' the left turn into the car park and reduce the risk of rear end collisions on South Road.

Alternative Access Arrangements: Examples Only for Consideration and Discussion

Both options may result in increased traffic using Gordon Road, between Byron Road and Cowper Road, in order to access the revised egress/exit points. For example, a resident of Cowper Street will have to use Gordon Road and Byron Road to enter the shops from South Road (in Option A), while a resident in Byron Road will have to use Gordon Road on their return to home.

Access to/from the shops is via driveways in Byron Road and Cowper Road, each approximately 10 metres from South Road. This results in some 'corner cutting' as drivers turn left from South Road directly into the car park, across the path of vehicles travelling west in Byron Road. Access can also be congested if 2 vehicles are queued in Byron Road or Cowper Road. These conditions are an unfortunate legacy of the original design and planning approval.

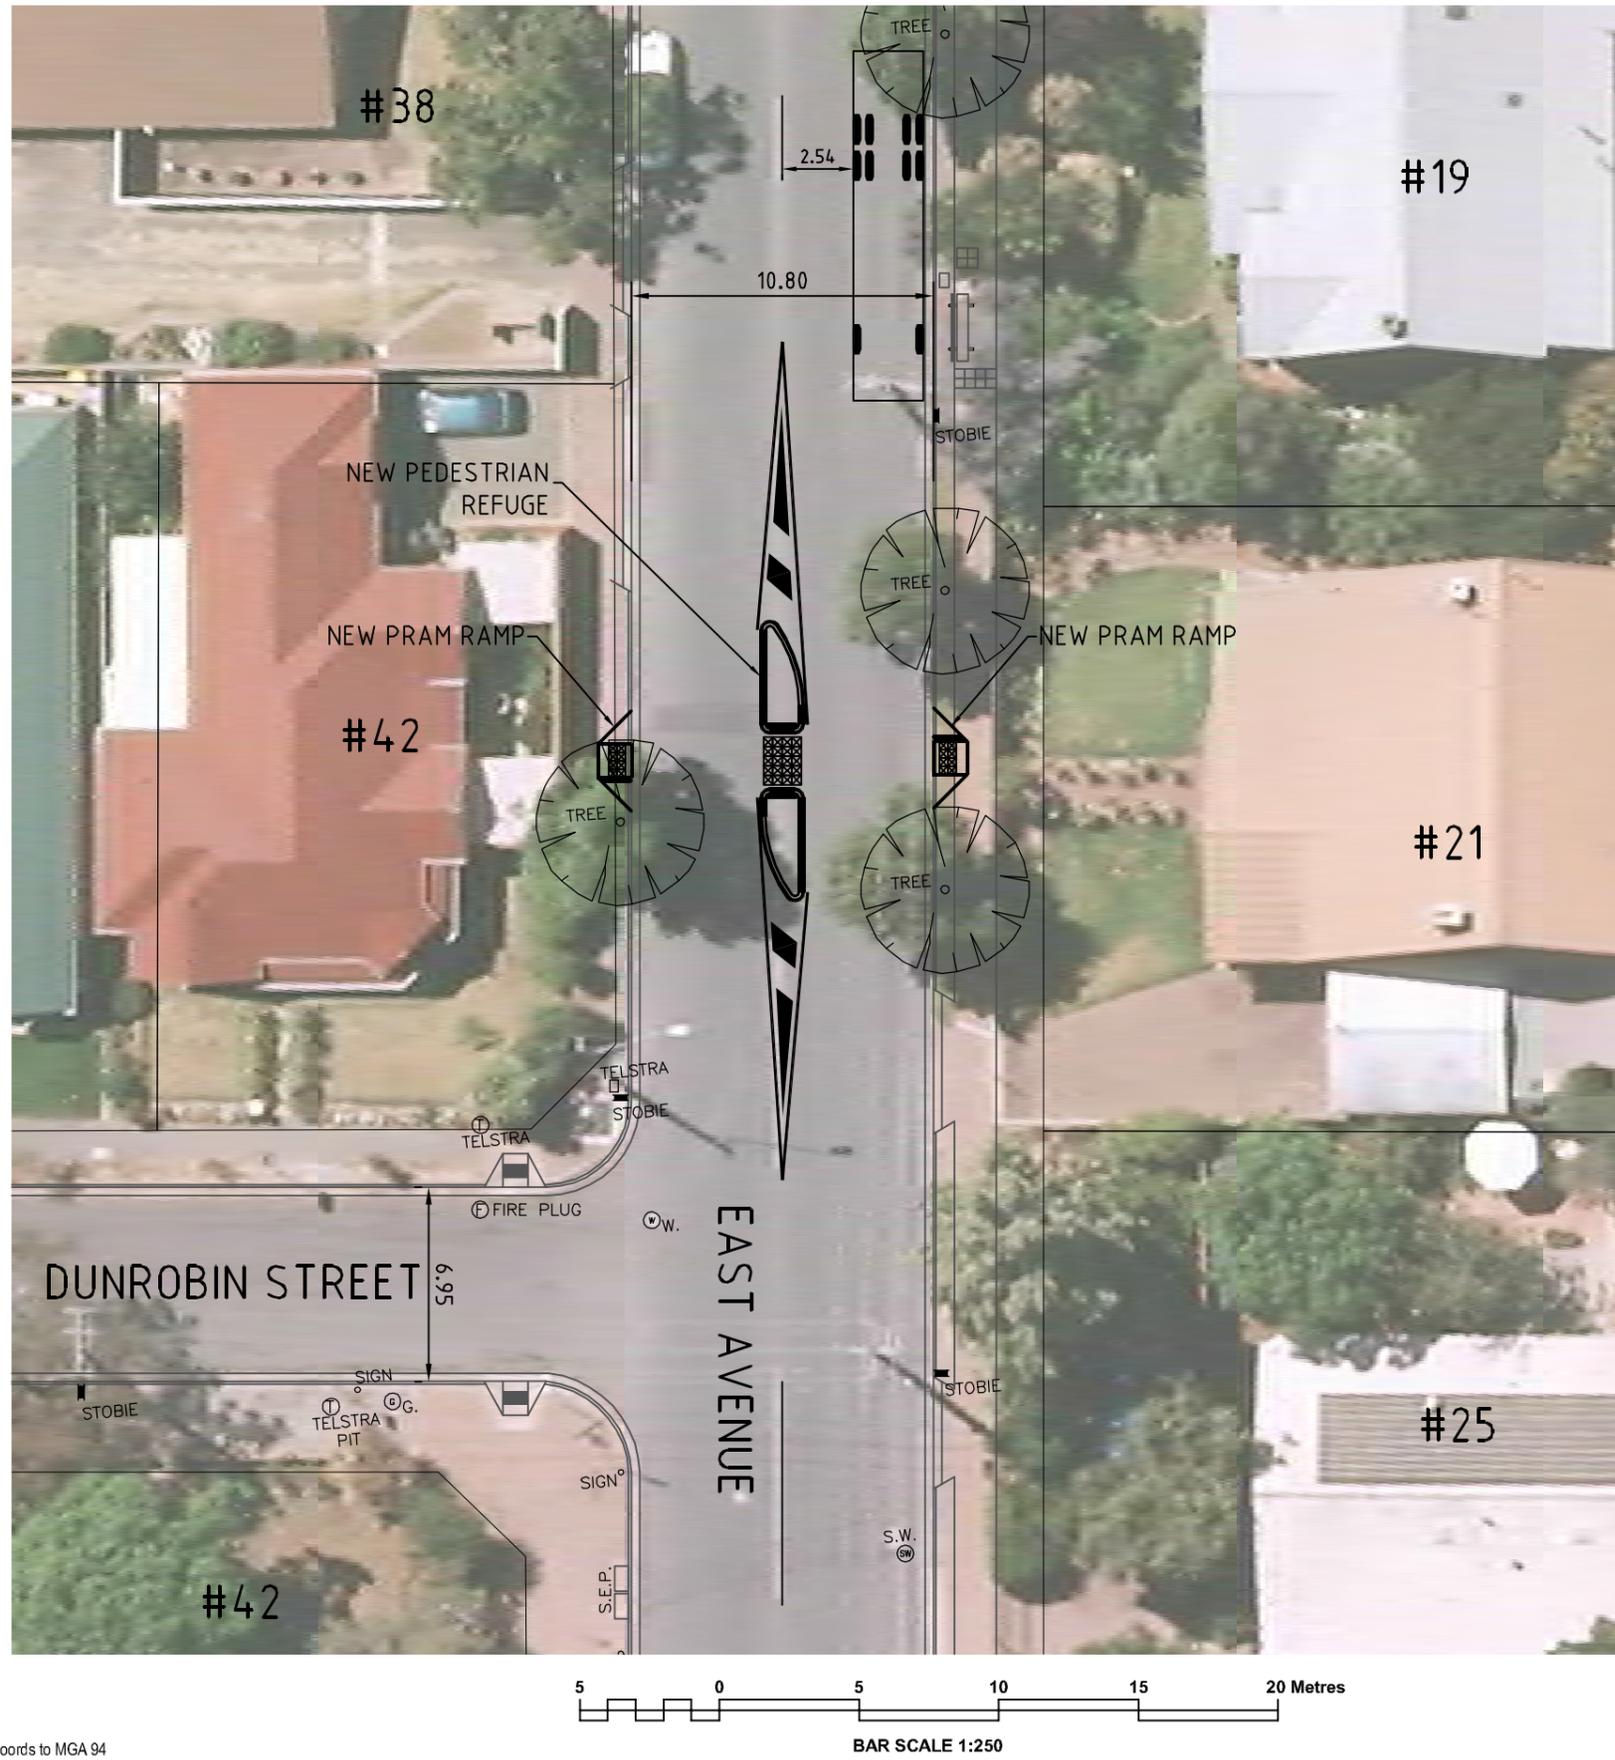
East Avenue Pedestrian Refuge

Unley Council
 East Avenue, Unley
